# African Journal of Humanities and Social Sciences

## Unstable Behavioral Pattern of Teesta River and Its Impact on Riverine Dwellers: A Case Study of Confluence Area of Teesta and Dharala River, India

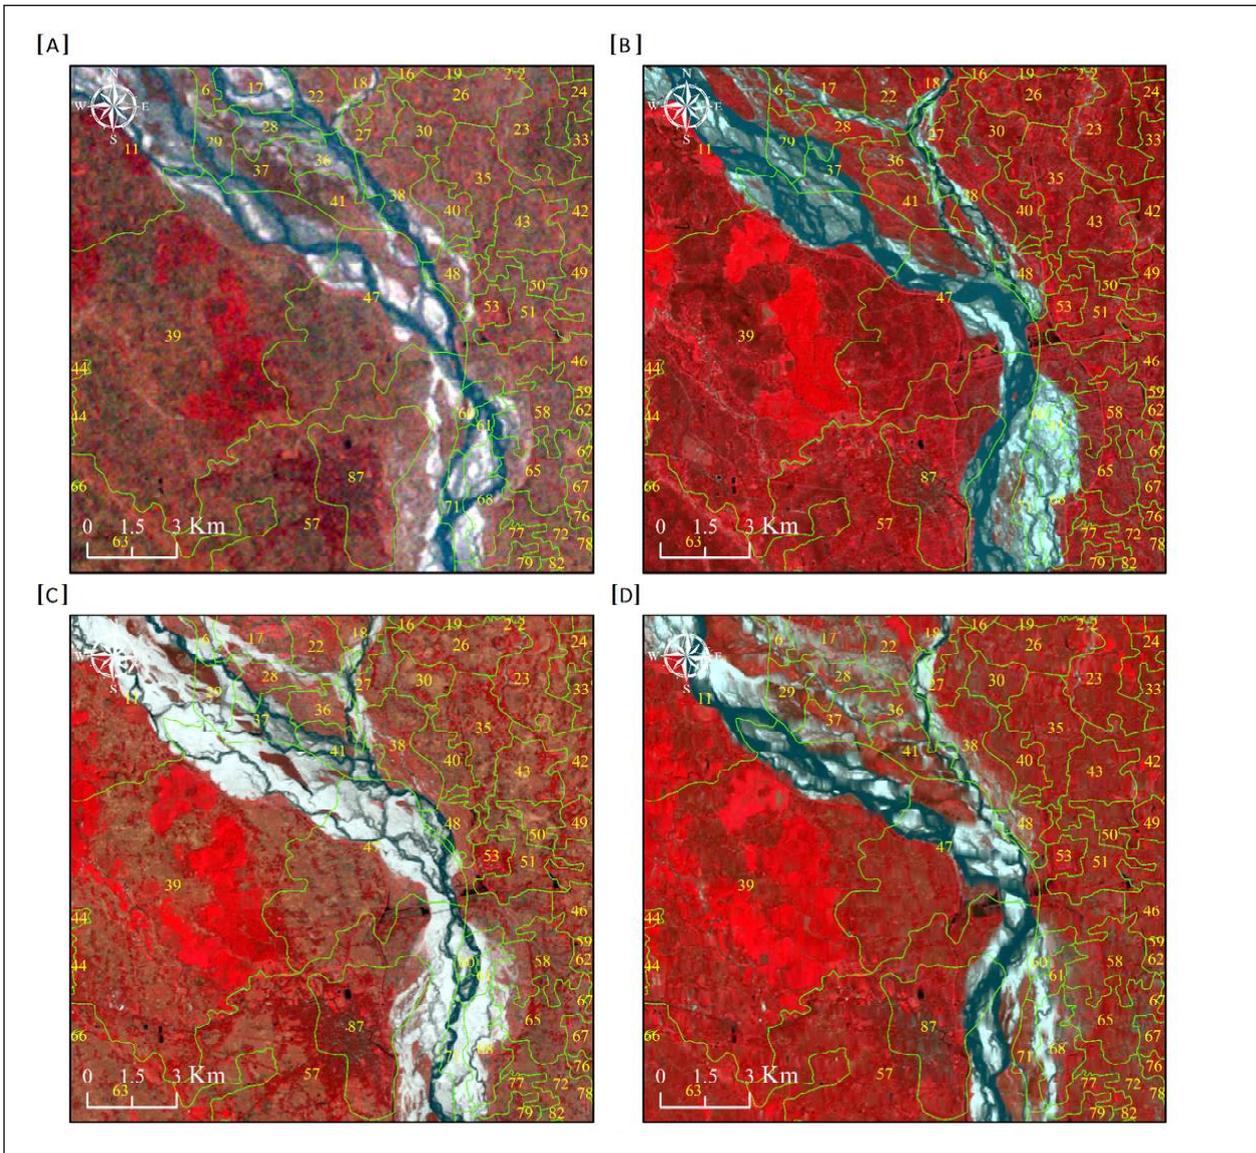
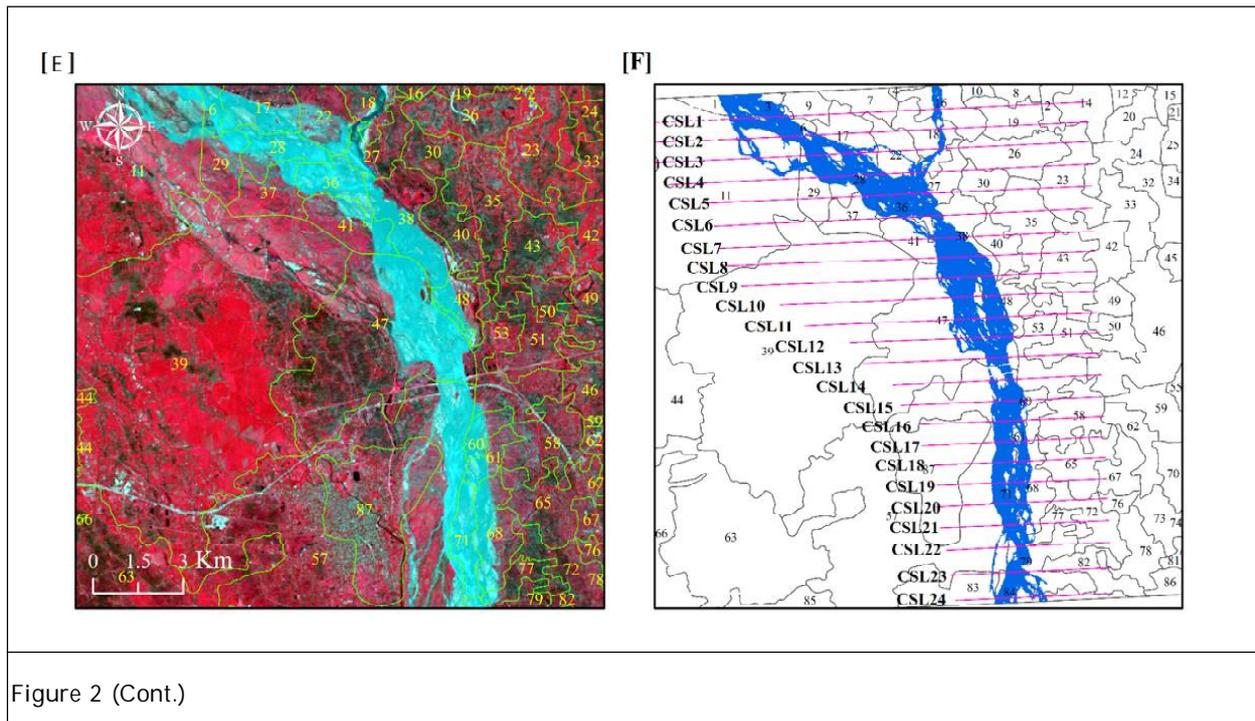
**Figure 2: Spatio-temporal scenario of the Teesta River course at Dharala River confluence (A) 1980 (B) 1990 (C) 2000 (D) 2010 (E) 2021 (F) Referenced Cross-section line**

There are several sandbars along the river beds, dispersed in character, as a result of low discharge in the river channel during the dry seasons. Digital image processing methods have typically been employed by researchers to separate the active river channel from other land cover groupings. Additionally, because it is difficult to delineate the active river channel, the researcher manually digitized it as a polygon form in ArcMap (Version 10.5). This same technique was applied for the all-temporal satellite images which were mentioned in Table 1.

The lateral displacement of the Teesta River channel has been computed from 1980 to 2021 while using 1980 as a base year (as illustrated in Figures 2 and 3). In this study, the total number of 24 cross-sections were taken into consideration to understand the nature of channel migration both quantitative as well as qualitative manners. In the upper portion of the investigated stretch, it was found that the maximum river course had been shifted. Cross-sections 1, 2, 4, 5, 6, 7, and 8 have been shown to be the most noticeable cross-sections where river courses were often changed between 1980 and 2021 (Figure 2). Between 1980 and 2021, the study area's average lateral displacement was calculated to be 642.72 m on the left bank and 1605.05 m on the right bank, whereas the actual average lowest lateral shift is calculated as 1140.90 m (right bank) in the period between 1980 and 1990 (Table 2) and 569.36 m (left bank) in the period between 2010 and 2021 (Table 2). On the other hand, average maximum lateral shift is calculated as 1934.30 m on the right bank and 1011.17 m on the left bank (2000-2010). From a statistical point of view, coefficient of variation is 0.93 (right bank) and 0.95 (left bank) during the period between 1980 and 2021 which indicates a comparatively high migration rate in both the river banks (for details see Tables 3, 4, 7 and 8). But within the successive time, there was several variability; whereas, between 2010 and 2021, the right bank has the largest coefficient of variance of channel shifting pattern (0.99) and 2010-2021 (1.33), 2000-2010 (1.15) and 1980-1990 (1.14) on the left bank (Table 2). However, the pattern of lateral migration was more stable between 1990 and 2000 (coefficient of variation: 0.53) on both the right bank and the left bank (coefficient of variation 0.88). Indicating discrete uniform distribution of the bank line shifting pattern away from the center line, the kurtosis value of the lateral shift for the right bank for the years 2000-2010 and 1980-2021 displayed a negative sign. It is interesting, in case of overall bank line

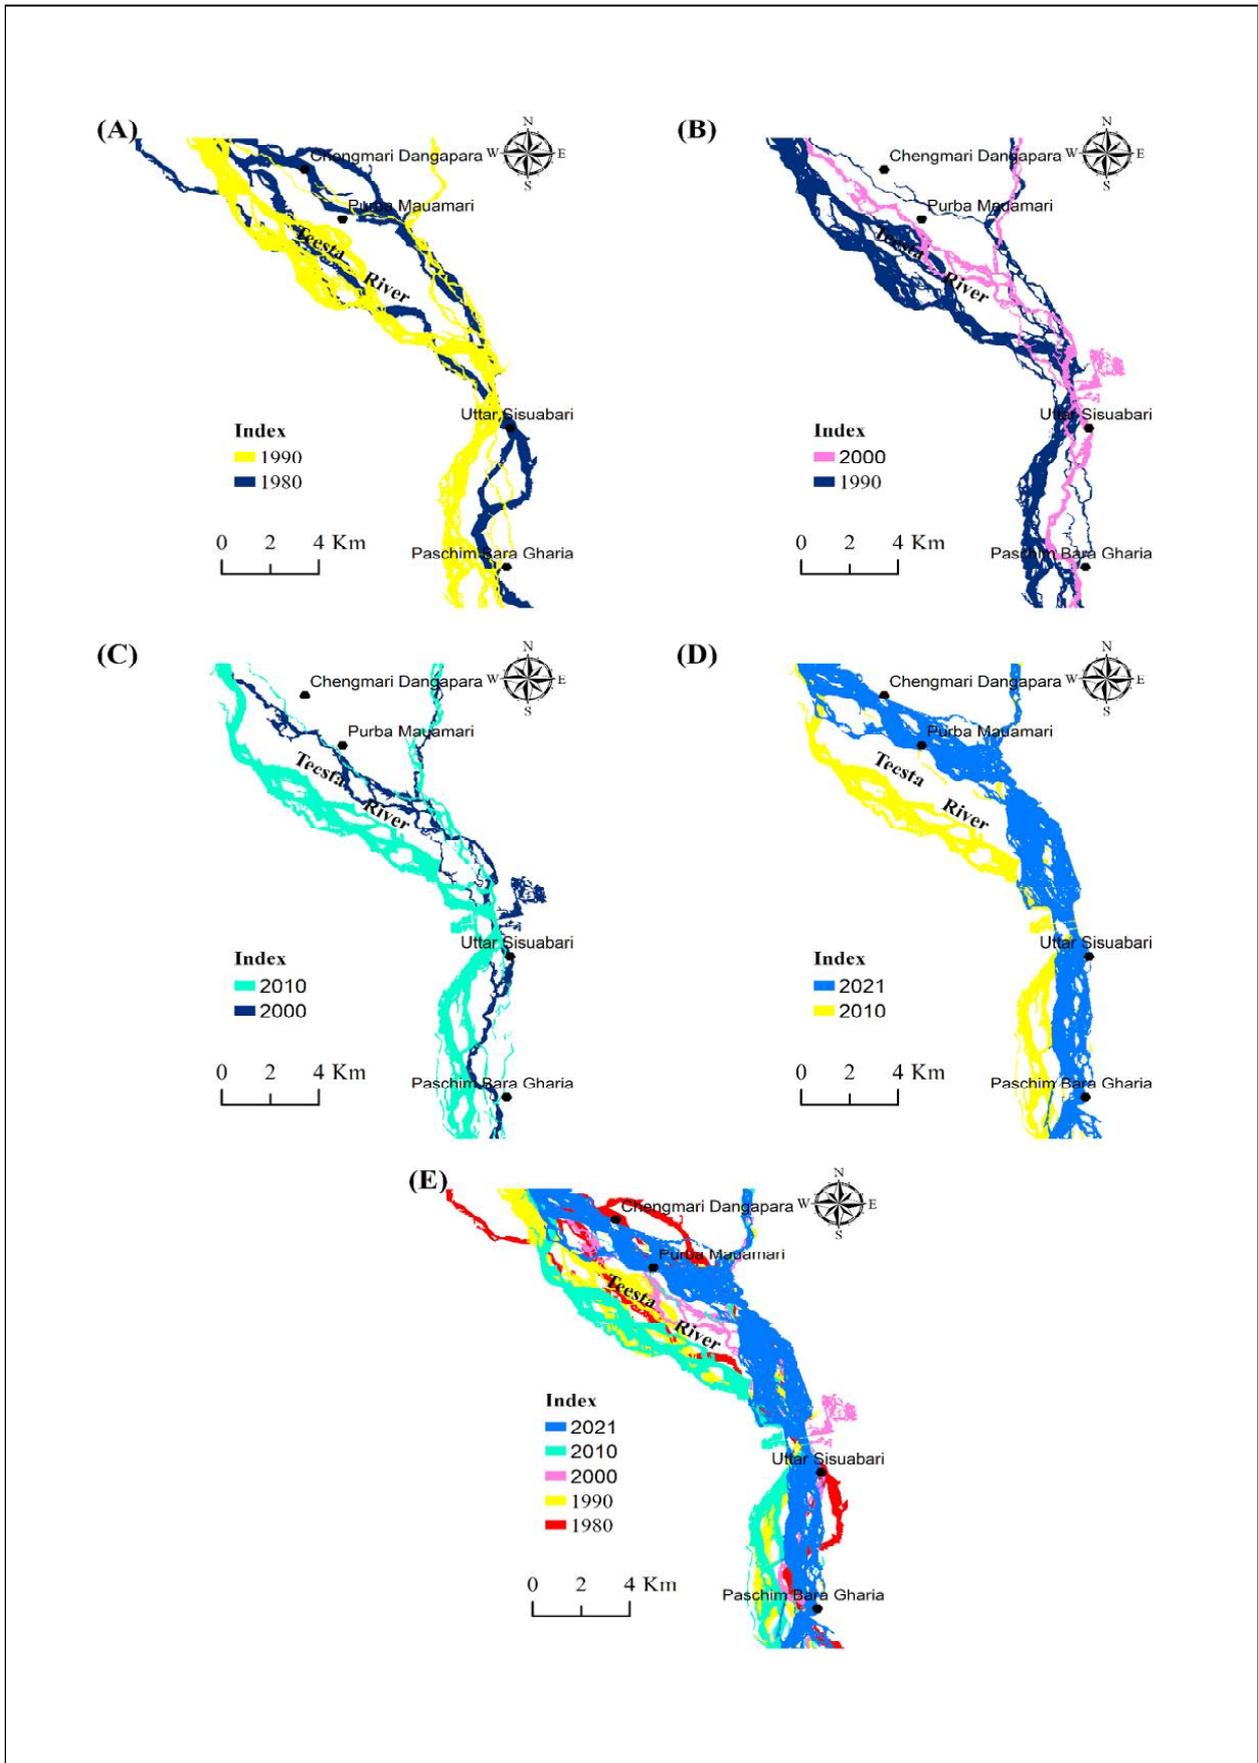
Figure 3: Temporal Shifting of the Active Flow Boundary (A) 1980-1990; (B) 1990-2000; (C) 2000-2010; (D) 2010-2021; and (E) 1980-2021

migration as the kurtosis value is -0.85 (right bank) and on the left bank 3.70 (Table 2) which indicates the platykurtic pattern (flat topped) and leptokurtic pattern of river course migration more or less prolonged migratory nature. Moreover, river course shifting directly affects the localized natural and human resources. According to 41 years of temporal analysis about oscillating behavior of the river course it is experienced that adjacent villages are prone to economic loss i.e., fertile agricultural land, standing crops, houses, and short-term human displacement. In the studied area several villages (i.e., Purbba Dolaicaon, Chengmari Dangapara, Chengmarihat, Dakshin Chengmari, Paschim Sangapara, Purbba Sangapara, Basusuba, Sisuabari, Barapatina Nutunbus, Paschim Mauamari, Paschim Premganj, Premganj Majhiali, Kharia, and Mandalghat) have a greater vulnerable experienced (Tables 5 and 6).

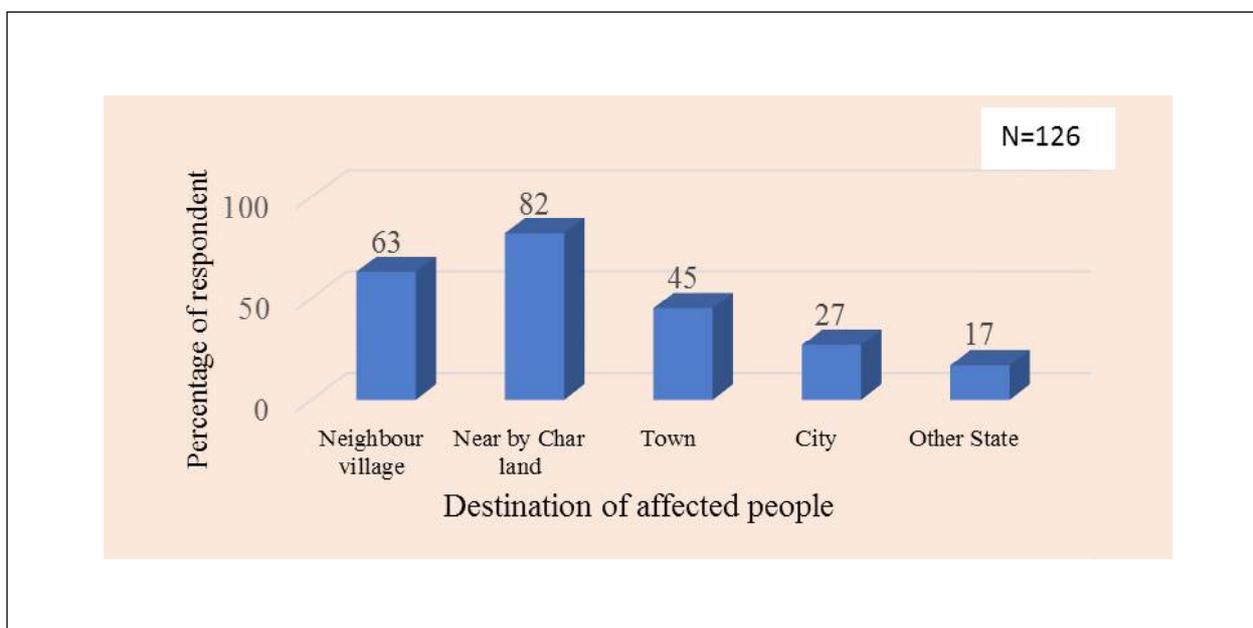
**Figure 4: Respondent’s Choice of Destination During Flood**

People who lose their jobs as a result of bank erosion go to other areas as migratory workers to meet their fundamental requirements (Das, 2014). People are mostly fleeing to neighboring villages and surrounding char land for safety (Mollah and Ferdaush, 2015). Even if a family has one or more male family members, they are accustomed to relocating to new locations for work and other reasons in order to improve their lives. 82% of the population are going to live in nearby char land and 63% of people arranged their settlement in neighboring villages (Figure 4).

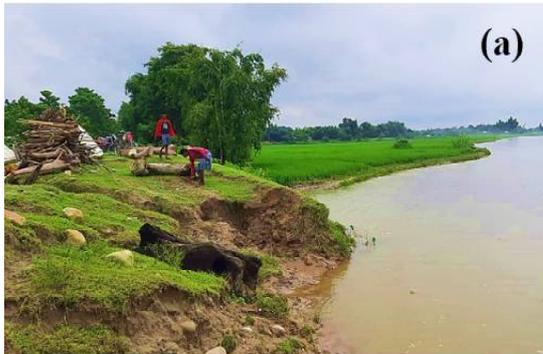
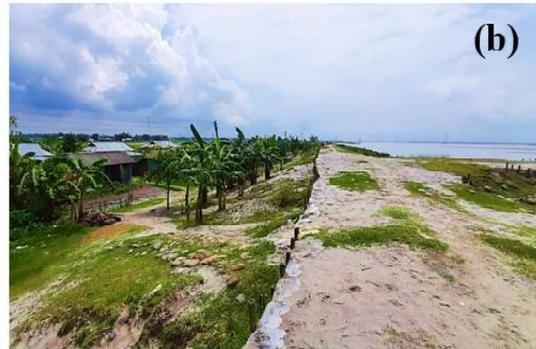
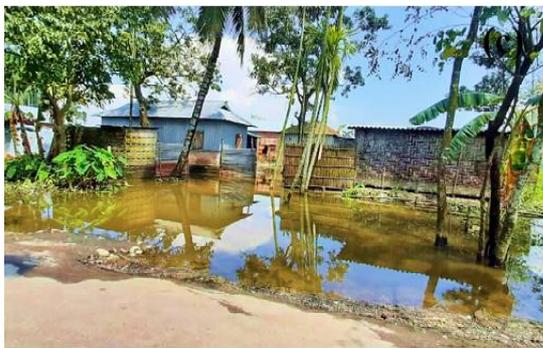
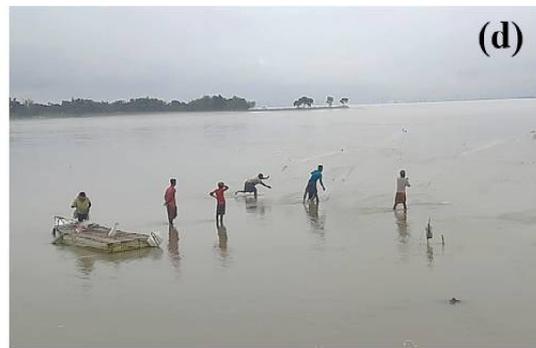
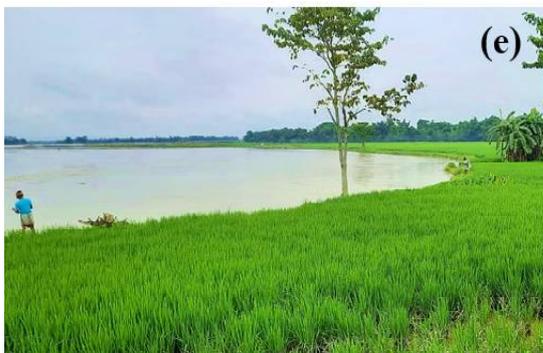
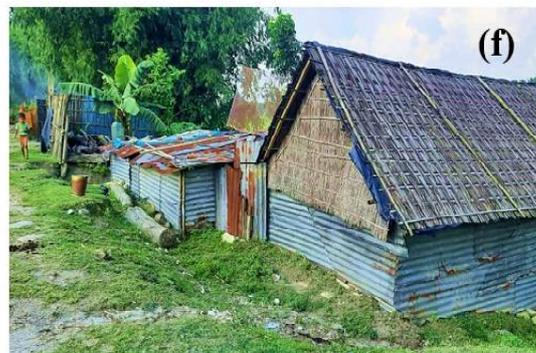
**Photo Plate 1: Overview of the Riverine Landscape and Human Lifestyle: (a) Bank Failure at During Monsoon; (b) Flood Protection by Embankment Construction Along the Left Bank of Teesta River; (c) Water Lodging After Overflow of River Water; (d) Fishing Activity by Riverine Dwellers During Monsoon; (e) Agricultural Practice on Fertile Riverine Landscape; (f) Permanent Settlements Displacement After Land Lost Due to Channel Shifting**

The River Teesta, which is part of the Brahmaputra River system, is one of the important rivers in North Bengal. The people of North Bengal live under the immense influence of the River Teesta. It has a major influence in the fields of drinking water, power, and irrigation (Rudra, 2021). It is very economically valuable and quite aggressive during the peak of the monsoon. The general characteristics of rivers have included bank failure, channel avulsion, and a horizontal oscillating pattern of the river course. However, the natural river also degrades or loses riverine resources, which is risky from an economic and environmental perspective. The research area has been focused in and around the confluence of Teesta and Dharala River in the Jalpaiguri district, West Bengal (Figure 1). In this study, a 25 km river stretch from the village of Purba Dolaicaon, located at  $26^{\circ}41'05''$  North and  $88^{\circ}39'49''$  East, in the upstream section of the Dharala confluence, to the village of Paschim Bara Gharia, located at  $26^{\circ}29'35''$  North and  $88^{\circ}45'58''$  East, in the downstream section, was considered to represent the vulnerability of river bed settlements as well as neighboring dwellers of the flood plain areas. Two railway bridges and two road bridges that have been constructed between the villages of Balapara and Dakshin Marichbari are impeding the natural flow of the Teesta River. Therefore, riverine settlements of this area are suffering from numerous issues, i.e., natural hazard like flood and bank erosion; economic aspects like losses of standing crops, destroying agricultural fields, collapsing of river bed settlements and agricultural job insecurity; and socio-cultural fields also suffering from local point of view. The study area covers 86 villages near the confluence of Teesta-Dharala River, which are under three blocks namely Kranti, Maynaguri, and Malbazar. Out of which 20 villages have direct experience of active flow condition throughout the year (Appendix).
